Commercial Vehicles and Vulnerable Road Users

COMMERCIAL VEHICLES AND VULNERABLE ROAD USERS

ASFC DATA SUMMARY 2004-2015

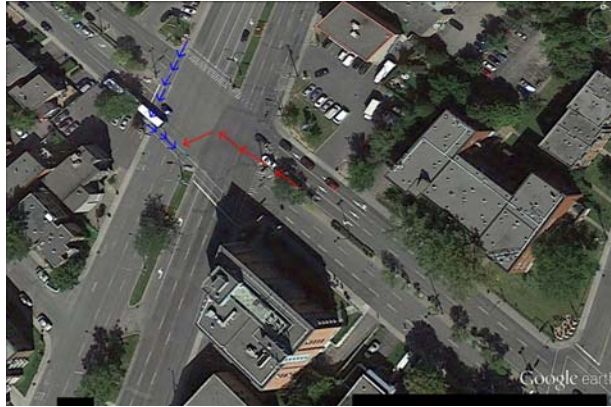
TRANSIT BUS - PEDESTRIAN

- A low-floor transit bus and an 42-year-old pedestrian.
- Pedestrian had ROW, was crossing road in the pedestrian crosswalk.
- Transit bus waiting for oncoming traffic to clear intersection

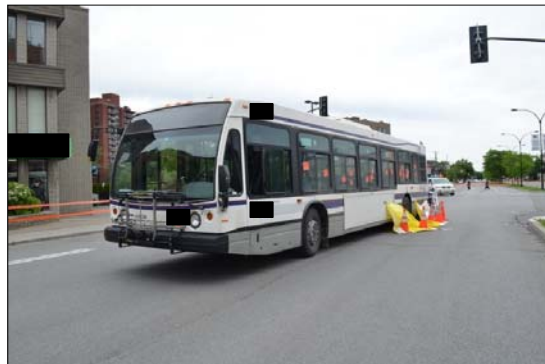
TRANSIT BUS - PEDESTRIAN

- Bus turned left and struck pedestrian with left-front mirror
- Pedestrian knocked to ground and run over by the rear wheels

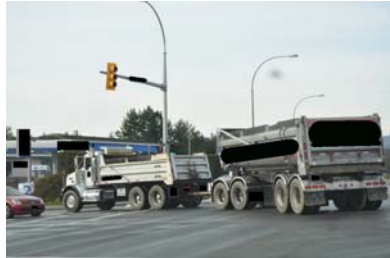
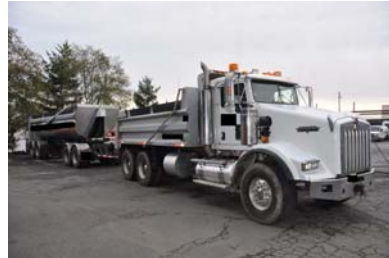
DUMP TRUCK - CYCLIST

- 2007 Kenworth T800 dump truck and a Midland 4-axle dump trailer
- Truck and cyclist were eastbound in the lane next to the curb
- As the cyclist cleared the intersection he moved left to avoid the curb
- At the same time the cyclist was overtaken by the dump truck
- After the truck passed the cyclist, the cyclist steered or drifted into the roadway a though he thought it was a single dump truck

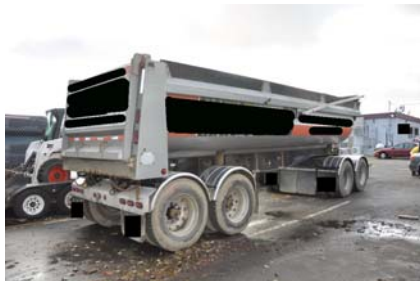
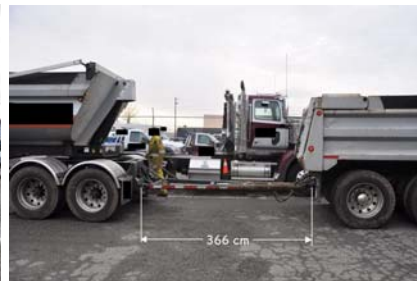
DUMP TRUCK - CYCLIST

- A witness reported that the left shoulder of the cyclist was clipped by the lead fender on the first set of tandem wheels of the trailer
- The cyclist fell to the ground and was run over by the second set of tandem wheels
