**TOOLS FOR PREVENTION:**  
*Investigating and understanding the human and organizational factors involved in the Sept. 2013 crash in Ottawa between an OC Transpo double-decker bus and a VIA passenger train.*

Christina (Missy) Rudin-Brown, Ph.D., CCPE  
 Manager / Senior Human Factors Investigator

Ontario Road Safety Forum – March 27, 2019

R13T0192  
Crossing Collision  
OC Transpo / VIA  
18 September 2013

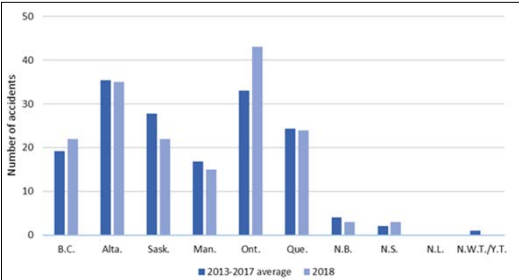
Level crossing accidents by province / territory, 2013 – 2018

- Although relatively uncommon (<1% of road fatalities), outcomes are substantial → top priority worldwide
- About 16,000 public level crossings in Canada
- From 2009 to 2018 (10 years) there were 1 708 level crossing crashes, with 224 fatalities

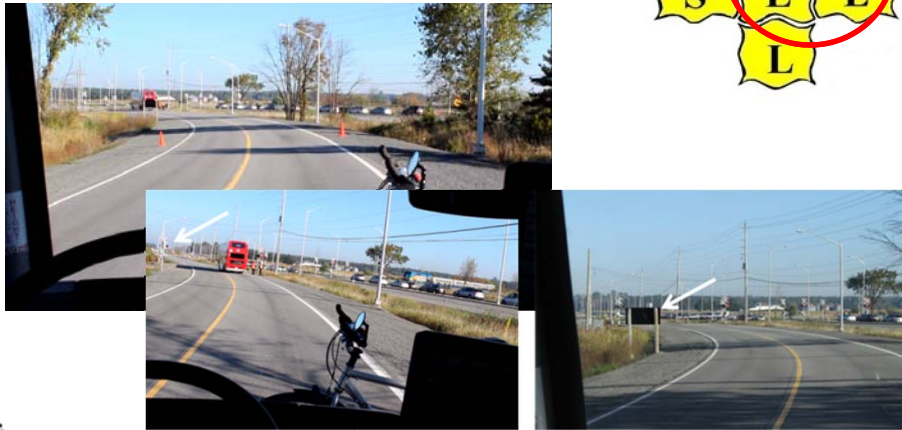
## 1. Accident re-enactment (September 28, 2013)

- Weather, position of sun, bus type & configuration
- Photos; video; braking analysis
- Speed of bus, train

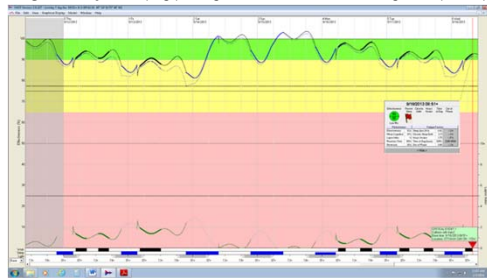
Fatigue analysis – (e.g.) Fatigue Avoidance Scheduling Tool (FAST):

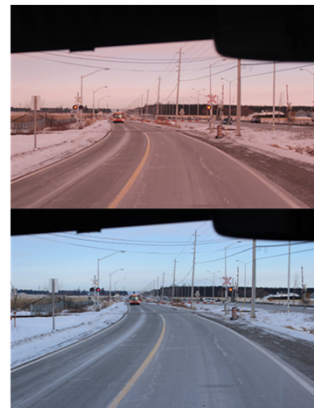
Colour vision deficiency - evaluation of polarized sunglasses:

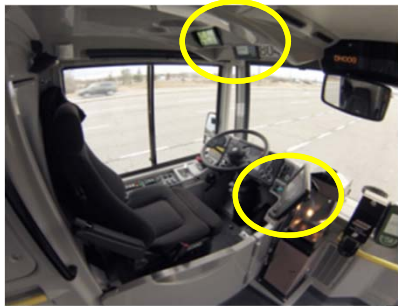
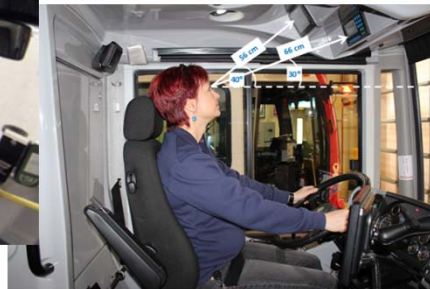
## 6. Ergonomic assessment of driver workstation

- Double-decker; 3 other types of bus (any Δ?)
- Bus drivers and mechanics
- Assessed:
  - accommodation and adjustability;
  - driver's reach to, and use of, controls; and
  - positioning and use of in-vehicle displays.
